INDOOR AIR QUALITY ASSESSMENT

**Virginia Blanchard Elementary School
65 East Hartford Street
Uxbridge, Massachusetts**

Prepared by:
Massachusetts Department of Public Health
Bureau of Environmental Health Assessment
November, 2001

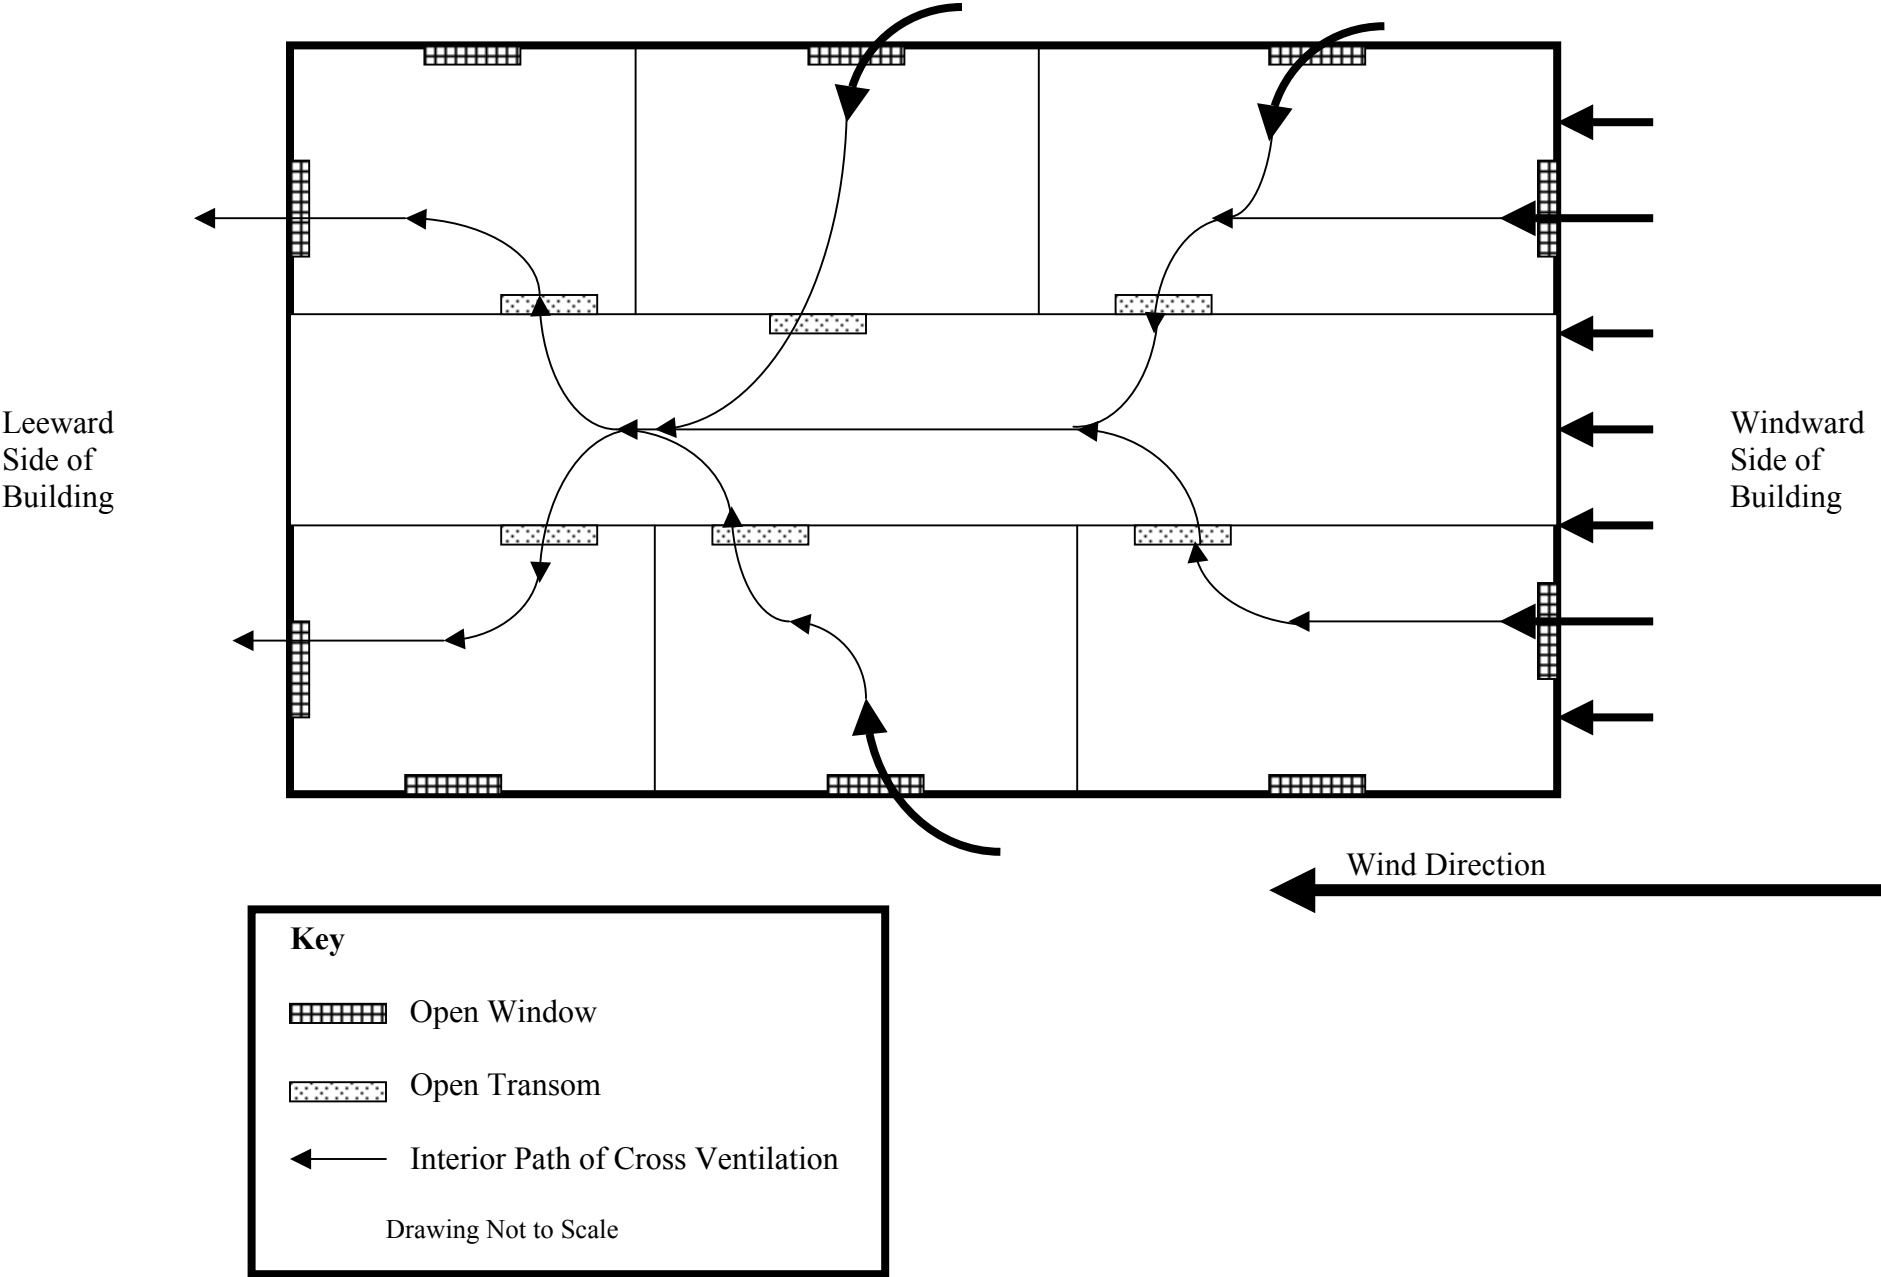
Figure 2

During summer months, ventilation was originally controlled by the use of openable windows in classrooms. This section was configured in a manner to use cross-ventilation to provide comfort for building occupants. The building is equipped with windows on opposing exterior walls. In addition, the building has hinged windows located above the hallway doors. This hinged window (called a transom) (see Picture 9) enables the classroom occupant to close the hallway door while maintaining a pathway for airflow. This design allows for airflow to enter an open window, pass through a classroom, pass through the open transom, enter the hallway, pass through the opposing open classroom transom, into the opposing classroom and exit the building on the leeward side (opposite the windward side) (see Figure 2). With all windows and transoms open, airflow can be maintained in a building regardless of the direction of the wind. This system fails if the windows or transoms are closed (see Figure 3). Each classroom would have a long pole with a hook that was used to open the hoop latch that locks the transom closed. Most transoms appear to have been permanently sealed during a previous renovation, which can inhibit airflow in the summer if hallway doors are closed. In addition, open windows may also allow for rainwater to penetrate through windows. Pests, such as birds, bats and insects, also have access to the interior if windows are left open overnight.

Cross Ventilation in a Building Using Open Windows and Transoms

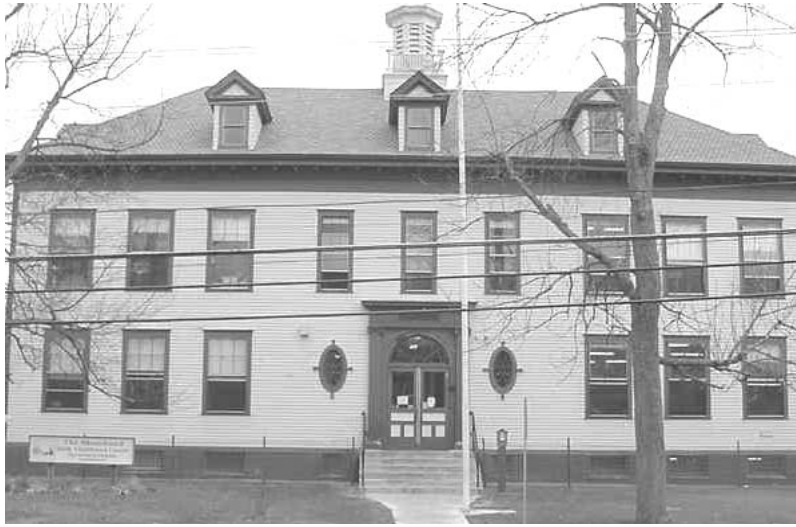
Picture 1

The school is a two-story wood clapboard exterior structure. The original school building was constructed in 1870 (see Picture 1). An addition was constructed in 1900 to the rear of the building (see Picture 2). The building has had several renovations to its interior since 1900, with the latest renovation subdividing the school administrative offices with an interior wall. Windows are openable throughout the building. Windows appear to be original wooden sash windows. Classrooms exist in the second, first and basement levels of the building. The front of the building has a finished attic that is currently used for storage. An unfinished attic space exists over the rear of the building and 1900 addition. According to school officials, renovations were done to the rear of the roof within the last 2 years. This project reportedly resulted in rainwater penetrating

The Original School Building, Constructed In 1870

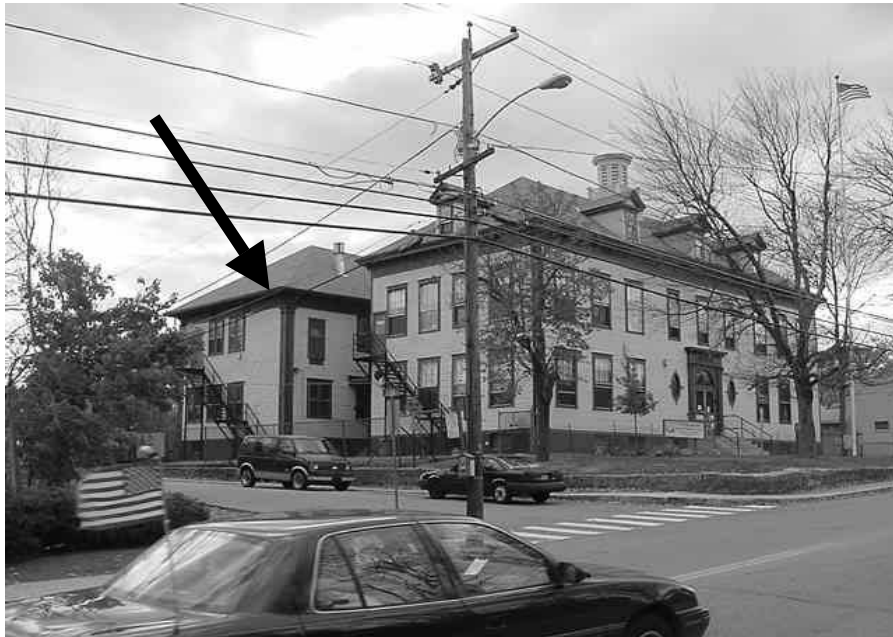
Picture 2

1900 Addition

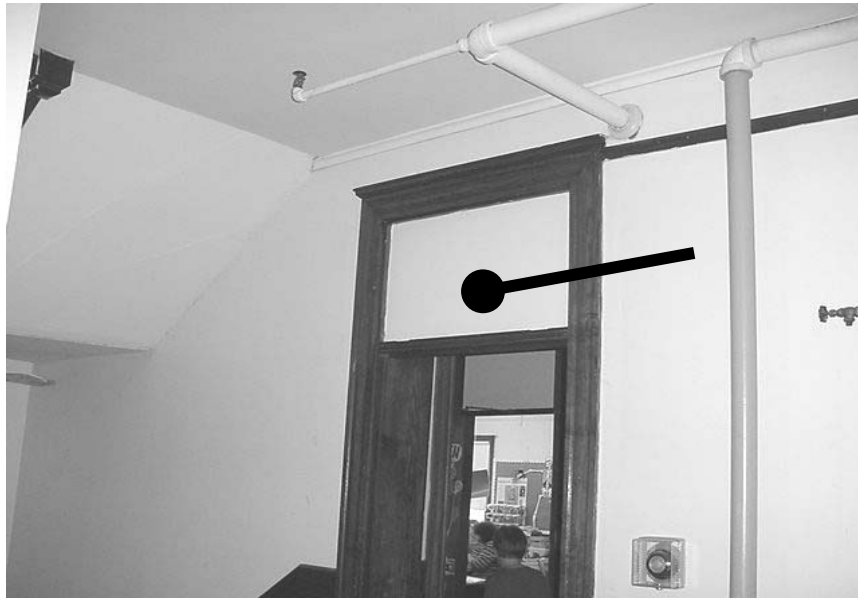
Picture 9

Hinged Window above Hallway Doors (Called A Transom)
